## Pioneer Irrigation District

### **Crews Complete Repair Work on Section Of Phyllis Canal Where Breach Occurred In April**

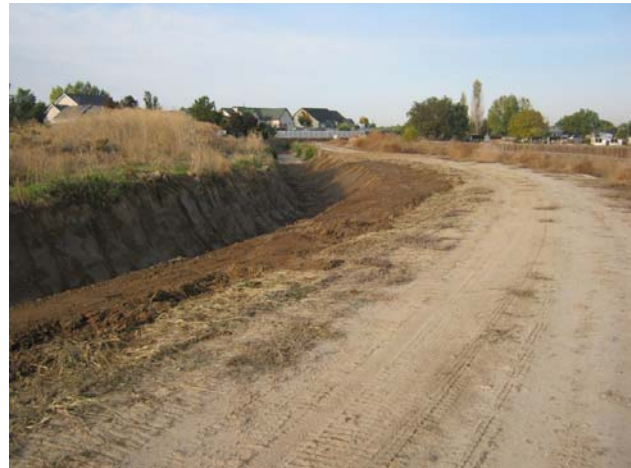
*Editor's Note: The accompanying photograph shows the repaired section of the Phyllis Canal where the canal bank was widened by almost 3 feet. (Photo by Pioneer Irrigation District)*

An investigation in April revealed the canal breach was the result of gopher holes in the bank. The rodents tunneled through the bank, which then provided a channel for water to trickle out of the full canal, eventually washing away enough dirt that a section of the canal bank collapsed.

Once water was out of the canal for the winter, Pioneer crews began excavating a portion of the south side of the bank in an area approximately 300 ft. long at the location of the breach. The excavated dirt was then packed onto the north side bank - the side that ruptured. That increased the width of the canal bank by almost 3 feet, reinforcing the structure.

The excavation and replacing of the dirt also reduced a severe curve in the canal at this location. Lessening the severity of the curve reduces water impact on the north bank, thus helping prevent erosion that could lead to future problems.
